RESILIENT PUBLIC ESTATE

CASE STUDY

THORNTON BRIDGE

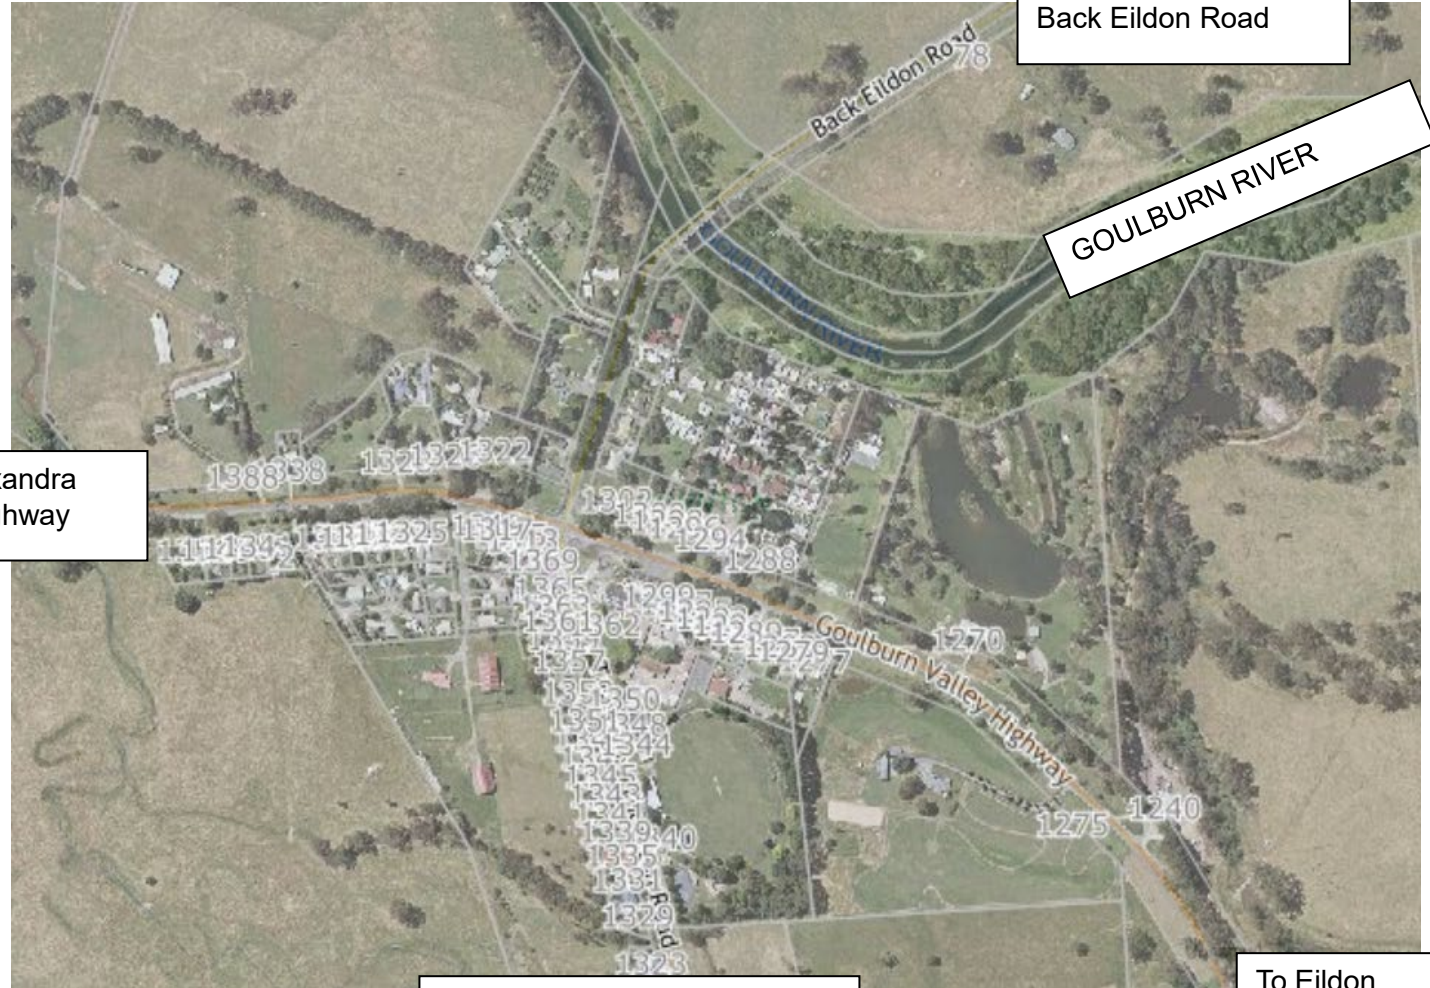
Thornton Bridge Context

To Eildon
Back Eildon Road

GOULBURN RIVER

To Alexandra
GV Highway

To Marysville, Melbourne
Taggerty Thornton Road

To Eildon
GV Hwy
